Title: Anodising and Corrosion resistance of AA 7050
Friction Stir Welds

Author: Pedro Atz Dick Gerhard H. Knörschild Luís F.P.
Dick

Anodising and Corrosion resistance of AA 7050 Friction Stir Welds

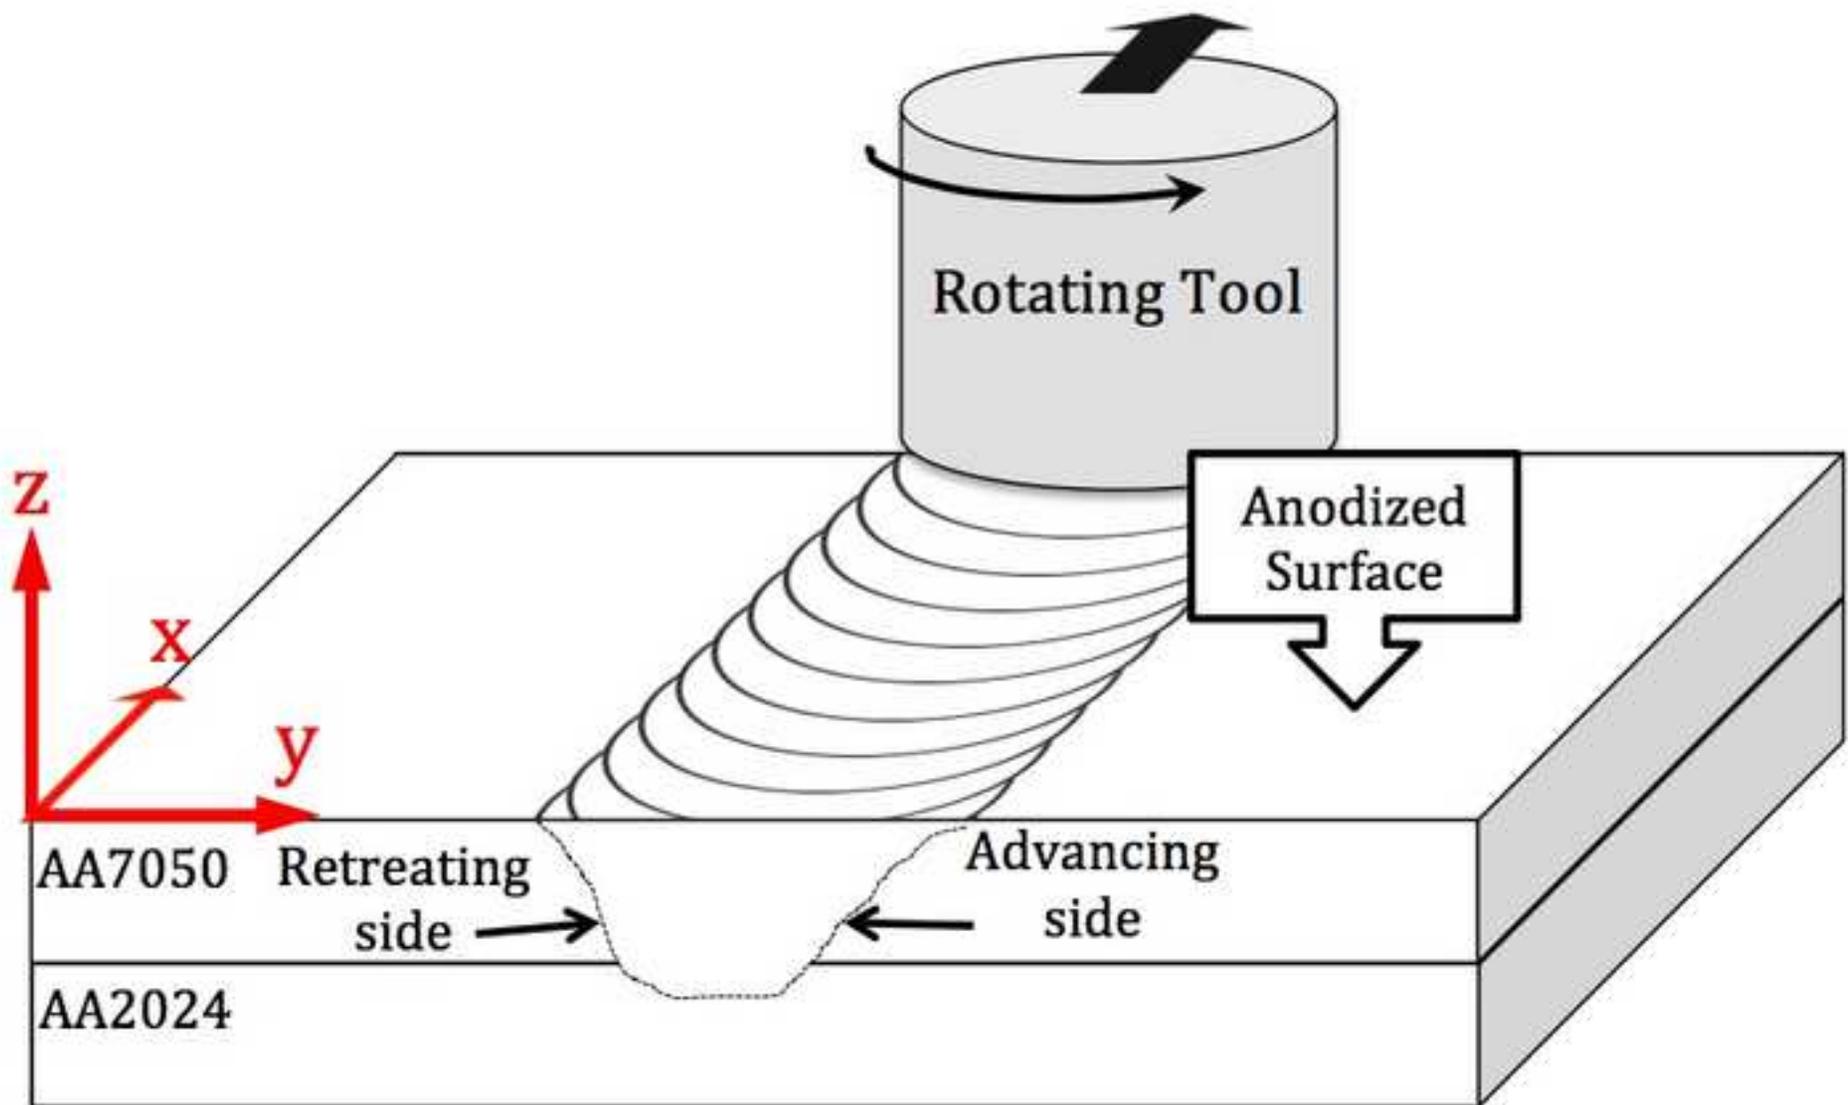
Figure 1

A lap joint between an AA2024-T3 sheet and an AA7050-T76511 extruded profile was friction stir welded using a welding speed of $960 \text{ mm}\cdot\text{min}^{-1}$ and a rotation speed of 1700 rotations per minute, as in a previous study [11]. This assembly represents the joint between an AA7050 stringer and the AA2024 skin of an aircraft, where the AA2024 alloy faces outwards and the AA7050 faces the inner side of the aircraft [20, 21]. During welding, the AA7050 profile was facing the tool. A schematic drawing of the welding process is shown in **Fig. 1**. The chemical composition of AA7050 was determined by optical emission spectroscopy as 6.16 wt. %Zn, 2.06 wt. %Cu, 1.88 wt. %Mg, 0.14 wt. %Fe, 0.10 wt. %Zr, 0.07 wt. %Si, <0.21 wt. % other elements and balance aluminium.

In order to study the protective nature of the anodic oxide film produced on the weld surface of AA7050 (*i.e.*, xy-plane in **Fig. 1**), current density maps were acquired using SVET with simultaneous anodic polarisation of -390 mV/SHE. It is important to note that the applied potential lies only 20 mV above the pitting potential of AA7050 [11] and is applied to accelerate the occurrence of localised corrosion on less protective oxide film sites. Several anodised FSW samples were analysed during exposure in 0.1 M NaCl solution and the corresponding current density maps always showed the nucleation of localised corrosion in the NZ. A typical series of acquired current density maps is presented in the example of **Fig. 9** that showed among other specimens a clearer time separation of individual pitting events.

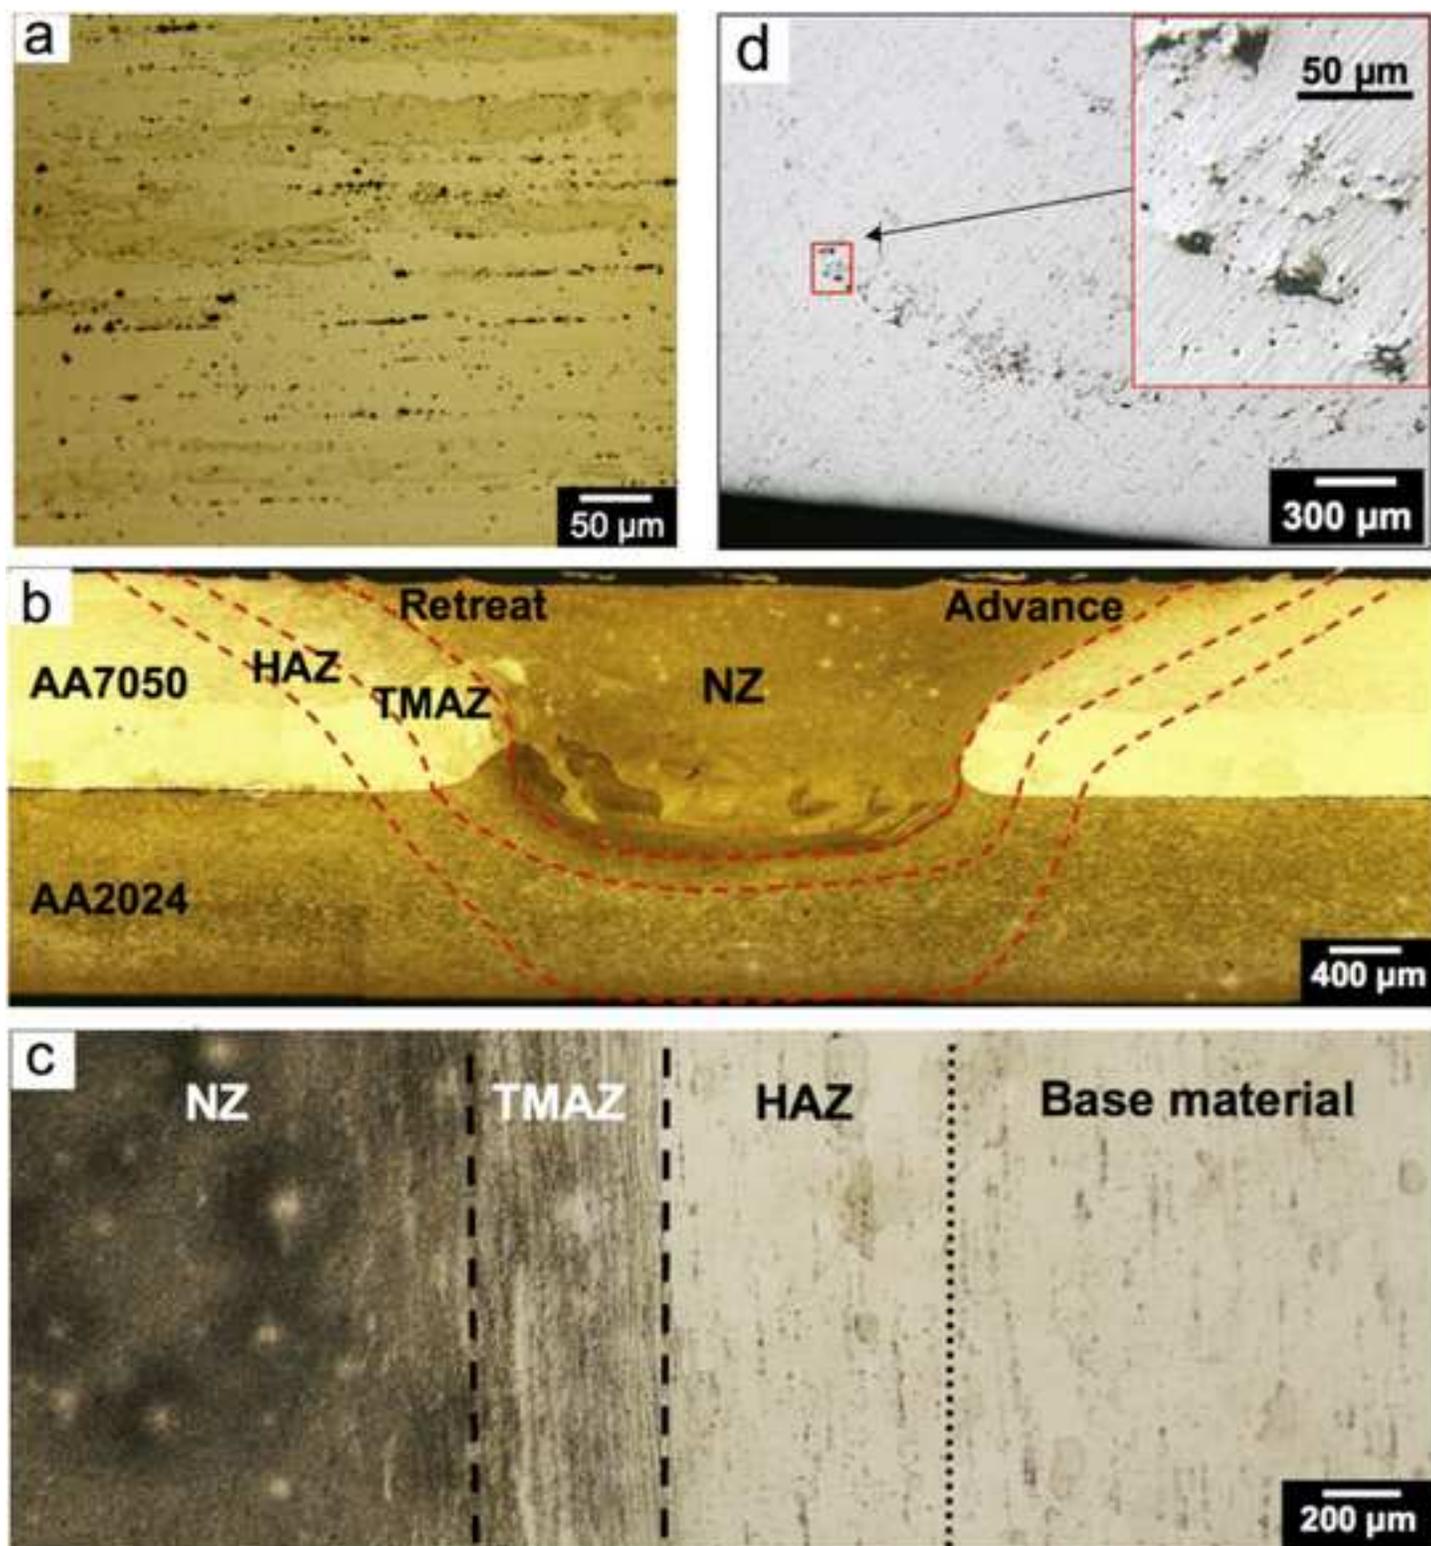
Fig. 2 shows optical micrographs of the base material alloy, the joint and its surroundings. The top view of AA7050 (**Fig. 2a**) shows an elongated grain structure, longitudinally aligned to the extrusion direction of the welded profile. **Fig. 2b** shows a cross section of the weld. It can be seen that the AA7050 profile has a different grain structure near the surface, characterised by coarser grains within a layer of $\approx 180 \mu\text{m}$ at the outer side and $\approx 600 \mu\text{m}$ at the side in contact with the AA2024 sheet. This structure results from the recrystallisation and growth caused by extrusion followed by the T76511 heat treatment (solubilisation, stretching and overageing) of the AA7050 alloy [23]. The typical FSW zones “nugget, TMAZ, HAZ and BM” can be recognized in the cross section in **Fig. 2b** or on the top view in **Fig. 2c**. The line representing the frontier between HAZ and BM was arbitrarily drawn, since no sharp difference between the microstructure of the two zones can be seen in the cross section or on the weld top view on the AA7050 side (**Fig. 2c**). This surface faces the tool during FSW and receives the most intense heat and deformation, losing its protective anodic oxide. For this reason, the corrosion resistance of the welded and anodized AA7050 side was studied in a first approach. Large voids with diameters around $10 \mu\text{m}$ aligned in the material flow direction are produced in the outer nugget region during stirring by the welding tool (**Fig. 2d**). These defects may result from non-ideal process conditions [1], such as a too low rotation speed, providing insufficient temperature and ductility of the alloy [24]. Further examination of inner regions of this type of joint can be found in a previous study [11].

The microhardness profile (**Fig. 4**) across the weld path has the typical “W” shape associated with welded age-hardenable Al alloys [28]. In a very narrow zone of around 1mm on the TMAZ-HAZ border there is a slight hardness drop from 190 to 170 HV due to precipitate coarsening. This agrees with low process temperature and tool rotation speed during FSW. Moreover, in the middle of the nugget zone there are some isolated low hardness points, where values as low as 140 HV could be measured with asymmetrical indentations. Thus, these apparently soft regions are actually explained by superficial elongated stirring voids, as the ones shown in **Fig. 2d**.

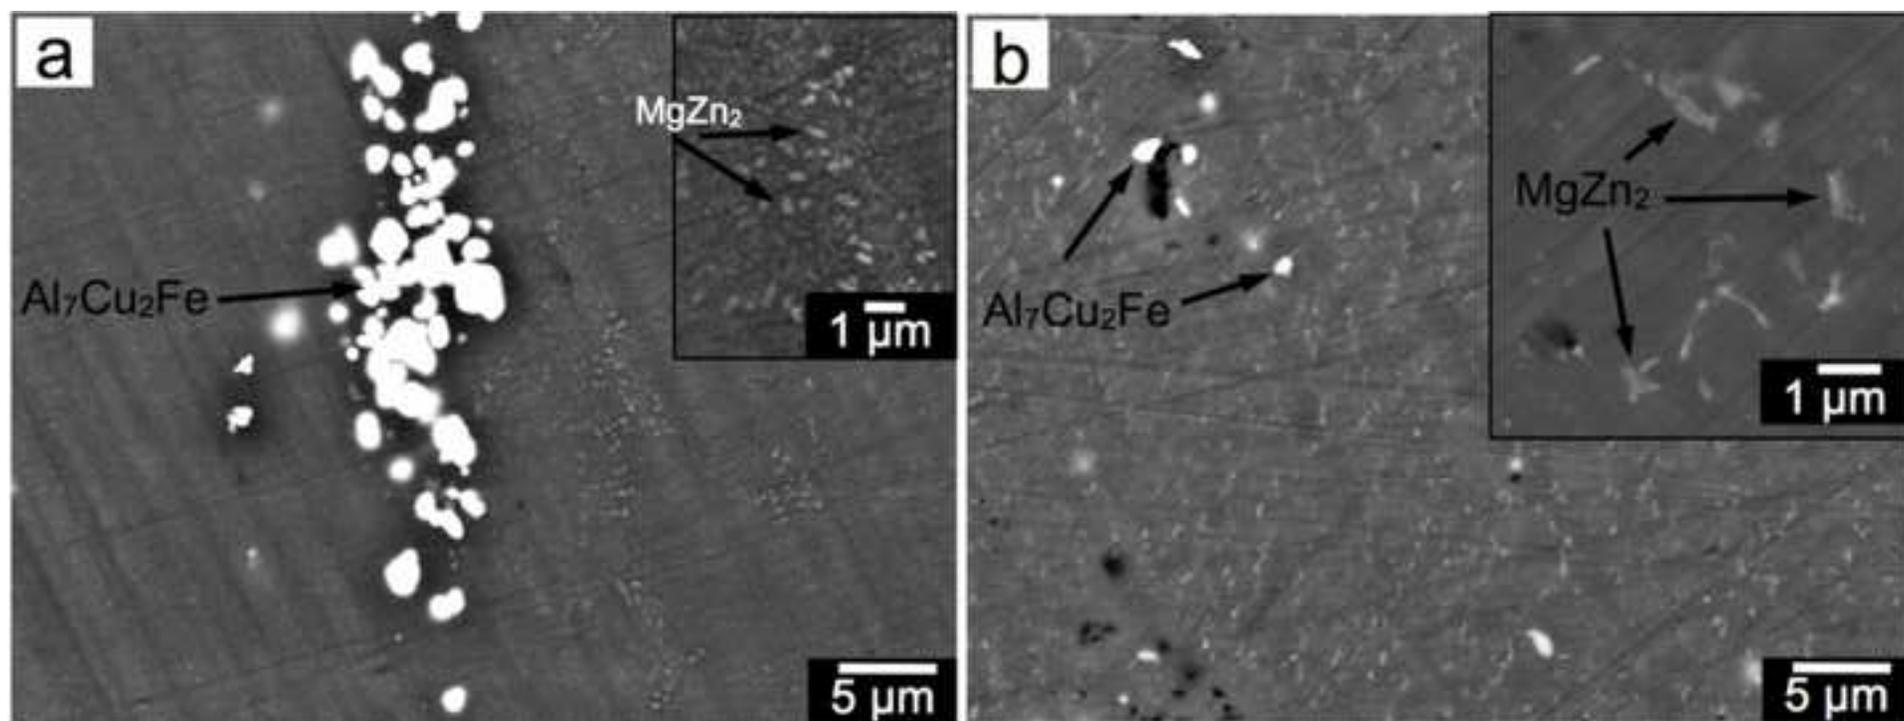
Figure 3

The microstructure of AA7050 revealed by SEM on the top surface is shown in **Fig. 3**. In the base material (**Fig. 3a**), the larger precipitates have a diameter of circa $2 \mu\text{m}$ and are aligned with the hot-rolling and extrusion directions. These precipitates were not dissolved

during the heat treatment, as expected for coarse precipitates formed during solidification. EDS analysis of their elemental composition ($\text{Al}_{7.4}\text{Cu}_{1.8}\text{Fe}$) allows the identification of these precipitates as $\text{Al}_7\text{Cu}_2\text{Fe}$ intermetallics. $\text{Al}_7\text{Cu}_2\text{Fe}$ is a common cathodic intermetallic in the AA7xxx alloy series and is related to a high Fe content, derived largely from impurities in alloy production [25]. **Fig. 3b** is a top view of the microstructure on the weld nugget. Here, the $\text{Al}_7\text{Cu}_2\text{Fe}$ particles are smaller-sized and randomly scattered by the friction of the tool. Apparently, these precipitates suffered partial solubilisation during FSW, because of high temperature and intense deformation imposed. In addition, small, elongated precipitates appeared in the NZ after welding. Considering that the dimensions of these particles are circa 100 x 700 nm, EDS analysis was not employed as a quantitative method, since a significant part of the output signal comes from the surrounding matrix. Nevertheless, EDS measurements on these particles revealed at least two times greater Mg and Zn contents in comparison to the matrix, specially under low beam acceleration voltage (10 kV) and reduced sampling volume, indicating that these precipitates are in fact MgZn_2 (η). Very fine particles with the same mass contrast are also found in the base material (**Fig. 3a**) and it can be inferred that these are η precipitates as well, although in this case they appear to be much smaller ($\approx 250 \times 250$ nm) and in lower number. It should be mentioned that $\text{Al}_7\text{Cu}_2\text{Fe}$ and η are the most commonly found precipitates in AA7050 alloys [26, 27]. Voids associated with metal stirring and precipitate fragmentation are present on the surface of the nugget zone, such as in **Fig. 2d**. The mass contrast in the SEM backscattering electron imaging mode is expected to be brighter for the AA7050 compared to the AA2024, due to its higher density. The analysis of mass contrast and elemental composition of the matrix shows that the vertical flow of AA2024 material in the weld does not reach the upper AA7050 surface and, as found in a previous work [11], is restricted to regions very close to the interface between the two alloys.

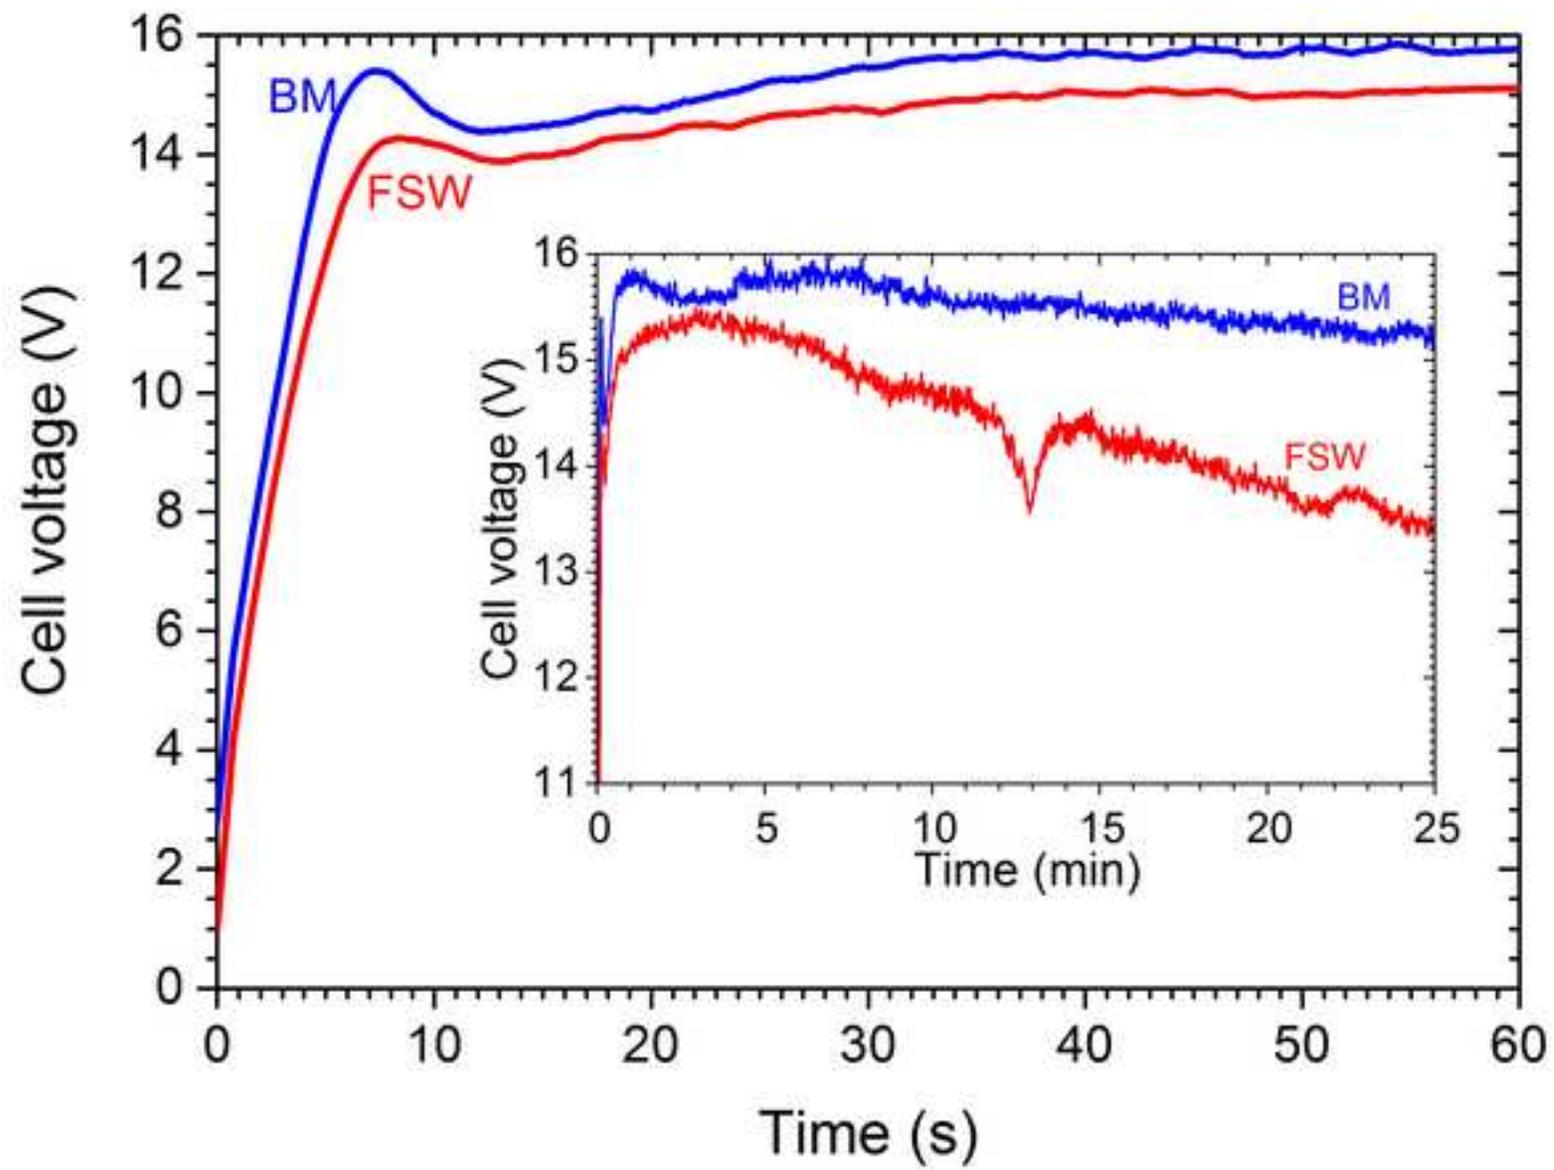
Figure 5

Cell voltage transients during anodising were acquired for BM and for welded specimens. From the results obtained, one typical voltage transient for each type of substrate is shown in **Fig. 5**. The inset plot shows the whole 25 minutes of anodisation, while the bigger plot is a closer look at the first 60 seconds. During the first circa 10 seconds, the voltage rises in quasi-linear time dependence, as expected for the initial formation of a barrier-type oxide layer at a constant growth rate. Comparing base material and the weld surface, which comprises nugget, TMAZ and HAZ, no considerable difference can be found at this part of the curve. After the first 10 seconds, voltage deviates from linearity, as a result of the morphological instability that initiates pore formation [29]. At this point, a voltage peak is verified only for the anodising of the base material, whereas for the welded specimens there is a smooth transition. This peak can be attributed to the nucleation of the first pores in the oxide, reducing the existing barrier-type layer to a thinner barrier layer at the bottom of the pores, and/or to the lateral growth of the thinned area [30]. A smoother transition to a porous type layer suggests that pore formation may be facilitated on the welded substrate, originating from voids or cracks in the barrier oxide, resulting from

abundant defects and microstructural heterogeneities in the weld. From pore formation up to the conclusion of anodising (**Fig. 5**, inset plot), the welded specimens displayed a lower cell voltage, i.e. a lower electrical resistance for the entire oxide, which can be explained by a more defective oxide in the weld region. The cell voltage at 50 seconds of anodising was chosen as a parameter for comparing stationary voltage values. At this point, the cell voltage was $15.8 \pm 0.1\text{V}$ for BM and $15.0 \pm 0.25\text{ V}$ for welded samples. Even though, the voltage after pore formation is not truly stationary and decreased with longer anodising times. All welded samples presented lower cell voltages than BM samples until the completion of anodising.

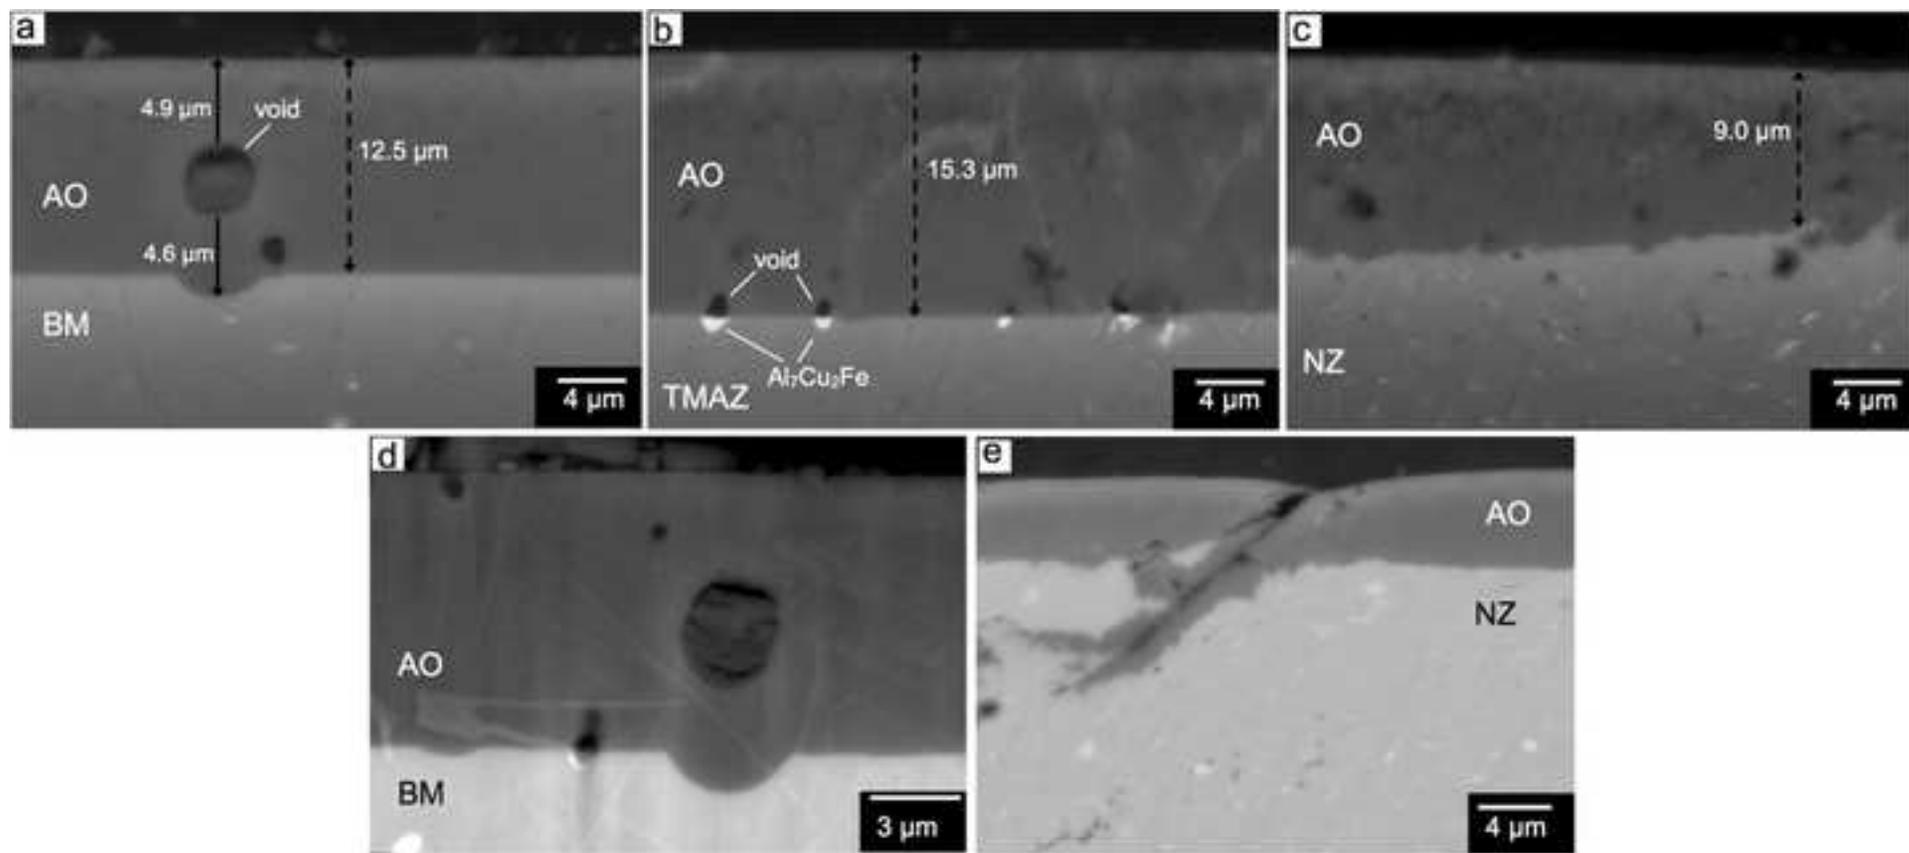
Figure 6

Figs. 6.a-e show cross-section micrographs of specimens anodised during 25 min in the sulphuric acid bath. The porous oxide layers obtained on the base material achieved a thickness of around $12\ \mu\text{m}$ (**Fig. 6a**). At some points, voids in the oxide layer could be found in association with increased thickness (**Figs. 6a** and **d**). These voids have a diameter compatible with that of $\text{Al}_7\text{Cu}_2\text{Fe}$ precipitates found in the alloy, indicating that these precipitates are dissolved during anodising. According to Fratila-Apachitei et al. [17], whenever the substrate-oxide front encounters copper-rich particles the current distribution changes promoting rapid oxidation and dissolution of these particles, due to their lower resistivity compared to that of the oxide. The voids in **Figs. 6a** and **d** are filled with a lower mass-contrast material with the same elemental composition determined by EDS as that of the oxide layer (Al, O and low concentrations of S) and is thus Al oxide or hydroxide with a lower apparent density than tubular Al_2O_3 formed on other sites. This oxide accumulates on the void side facing the metal and can be attributed to the selective dissolution of Cu and Fe from the precipitate, forming an irregularly porous and more

permeable alumina structure deposited on the dissolution front. The oxide front does not seem to advance more rapidly on the $\text{Al}_7\text{Cu}_2\text{Fe}$ /oxide interface compared to the Al-matrix/oxide one (**Fig. 6b**). However, after complete $\text{Al}_7\text{Cu}_2\text{Fe}$ particle dissolution and further formation of tubular porous alumina, the oxide front advances more rapidly and the final total film thickness is greater where these particles dissolve. This is compatible with an oxide film formation controlled at least partially by migration or diffusion transport of species along the regular tubular pores of the alumina film.

In comparison with the oxide layer on the BM(**Fig. 6a**), the oxide layer on the TMAZ (**Fig. 6b**) is around 20% thicker. On the NZ (**Fig. 6c**) the oxide thickness varies, with values down to 50% of the oxide thickness found on the BM. Furthermore, the oxide thickness measurements performed by optical microscopy perpendicularly to the FSW joint (**Fig. 7**) show that the oxide film forms faster in regions where the hardness is lower.

With exception of the locations where coarse precipitates were dissolved, flat interface (**Fig. 6a, b**) and constant oxide thickness (**Fig. 8a, b**) were found for the base material, HAZ and TMAZ. This is expected if the porous oxide formation rate is controlled by the same process along the metal/oxide interface. The transport of species across the barrier oxide on the bottom of the oxide pores has been considered as the rate determining step during the initial stages of oxide formation [32]. As the oxide layer grows, we can expect that transport processes by diffusion or migration along these pores will increasingly limit the formation rate. This could explain the fact that the oxide front of thicker layers does not advance significantly faster during the dissolution of coarse $\text{Al}_7\text{Cu}_2\text{Fe}$ precipitates (**Fig. 6b**). However, after dissolution of $\text{Al}_7\text{Cu}_2\text{Fe}$ and formation of a less dense oxide or hydroxide filling the dissolution void of the precipitate, transport is favoured and the film formation becomes faster resulting in a locally thicker AO layer (**Figs. 6a and d**).

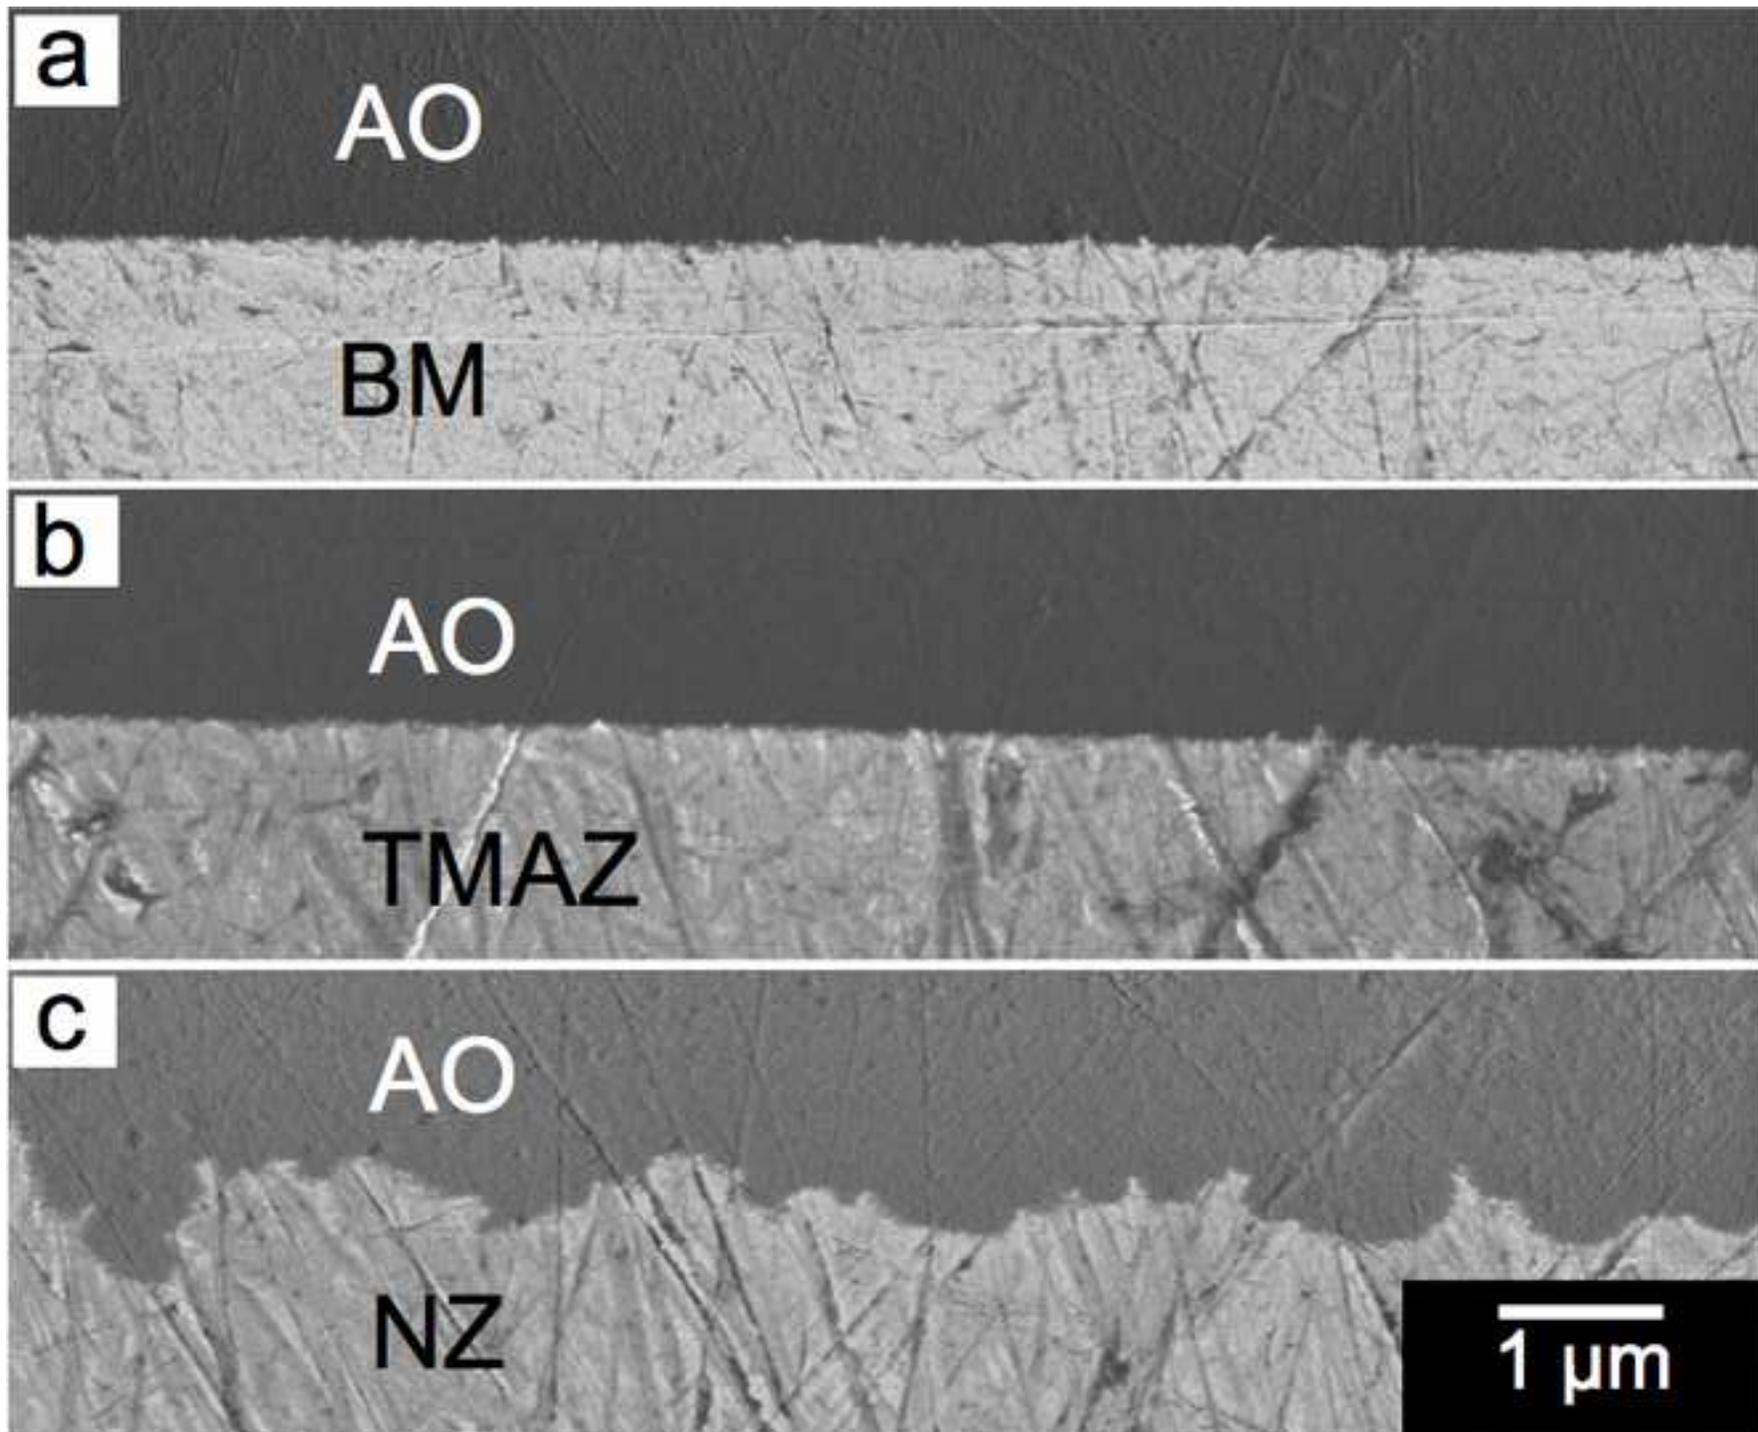
Figure 8

The shape of the substrate/oxide interface seems to vary depending on the substrate (**Fig. 8**). On the base material (**Fig. 8a**), HAZ and TMAZ (**Fig. 8b**) the oxide front is flat, except for occasional protuberances related to the dissolution of coarse $\text{Al}_7\text{Cu}_2\text{Fe}$ particles, whereas the oxide front on the nugget zone (**Fig. 8c**) is rougher with protuberances even in areas where no cracks or porosities were left by FSW. As a result, the optical brightness of the BM, HAZ or TMAZ polished surfaces is not significantly affected by anodising (still some opacity is produced), while the NZ (formerly not visually detectable) darkens due to metal/oxide interface roughening.

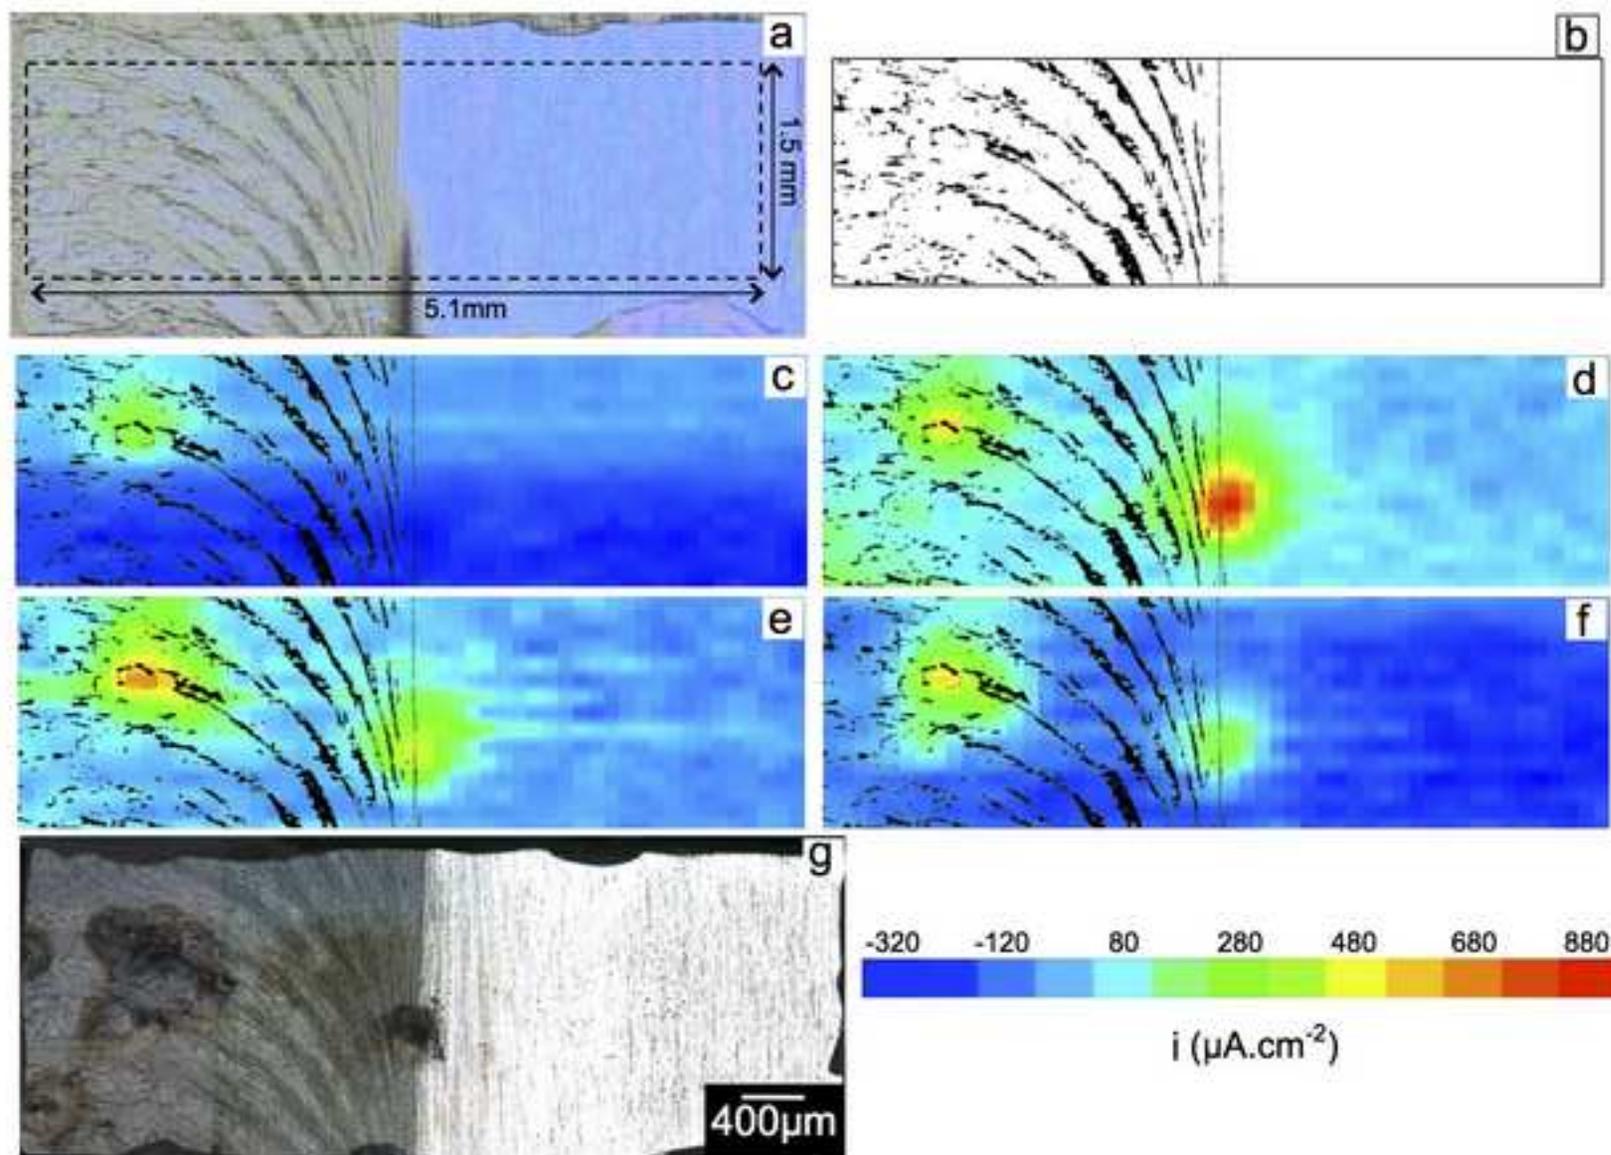
Figure 9

The exposed area (**Fig. 9a**) extended laterally from the nugget's centre (advance side) to a point on the base material region, comprising from left to right: nugget zone, TMAZ, HAZ and base material. The area framed by the dashed line represents the portion of the original surface scanned during the measurements. To better understand the results, this picture was converted to a binary image (**Fig. 9b**) and overlaid on current density maps. Although the maps were acquired every 15 minutes, only the maps considered more relevant will be

The acquisition of the map in **Fig. 9c** started after 2 h of exposure to the electrolyte. The maps acquired before that time showed little activity. The global current density is practically zero during the first 1.5 h of test (**Fig. 10a**). Thus, there appears to be an incubation period, during which slow processes occur, such as the withdrawal of air from the oxide pores and their filling with electrolyte and the migration of Cl^- ions through the barrier layer at the bottom of the pores. Next, the current starts rising slowly, which may be the manifestation of oxidative processes caused by the penetration of Cl^- . Right before 2 h of test, the current reaches a sudden peak. This peak is attributed to pitting corrosion and, therefore, the anodic region on the nugget in **Fig. 9c** can be identified as the site of the first pit.

Fig. 9d shows the current density map scanned 2.5 h after the beginning of the test. The first pit continues to be active, and now we have a second strongly anodic zone at the frontier between the nugget and the TMAZ, with currents reaching $800 \mu\text{A}\cdot\text{cm}^{-2}$. In addition, another anodic region is seen in the lower left corner of the map. The positive currents measured in that place may originate in a corrosion event happening outside the scanned area. Both new anodic zones seem to be caused by nucleation and growth of pits. This is confirmed analysing the optical micrograph of the sample after the test, **Fig. 9g**, where the two pits can be seen. In the diagram displaying the global current density (**Fig. 10a**), one peak is found right before the beginning of that scan (2.5 h) and one right after.

Considering that each scan took 7 minutes, both of them could be caused by both pits. The next two maps (**Figs. 9e** and **f**) indicate repassivation of the pit at the lower left corner, as well as a modification of the shape of the first anodic zone. With support of **Fig. 9g**, it can be said that this anodic zone changed its shape because new pits nucleated adjacent to the first one.

As seen in **Fig. 9g**, pitting corrosion occurred in the nugget zone and at the frontier between nugget and TMAZ. In fact, the nugget zone and its frontier with TMAZ on the advance side presented an anodic oxide layer with thickness as little as 50% of the values encountered on other zones and on the base material (**Figs. 6a-c**, **Fig. 8**). Since these regions have a thinner porous oxide layer, the permeation of electrolyte is expected to occur faster, allowing earlier penetration of Cl^- anions and degradation of the barrier layer. From then on, metal dissolution is promoted by Cl^- and pitting corrosion begins. Accordingly, defects in the porous layer on these regions may ease the penetration of Cl^- [31] and hence promote pitting. It can be noted that the pits found in the nugget region of **Fig. 9g** are localised mainly on the arched lines present in the nugget. These lines become apparent after anodising and are the same shape as the stirring voids.

As verified by the SVET measurements for samples polarised slightly above E_{pit} , the thinner porous oxide layer combined with the presence of defectively anodised FSW stirring voids decreases the resistance to pitting on the NZ (**Fig. 9**). From sequential SVET maps, it was possible to determine individual pit currents. Considering the exposed area of $11.6 \cdot 10^{-2} \text{ cm}^2$ and the current density values of **Fig. 10**, the global current is around one order of magnitude higher than the added single pit currents. Possible reasons for this are the assessment of only a fraction of the total current arising from individual pits at the surface distance where the oscillating electrode tip is placed ($50 \text{ }\mu\text{m}$) and the lack of knowledge of the exact conductivity of the electrolyte at the pit opening region. The more concentrated electrolyte at this place and resulting higher local conductivity lead to the underestimation of the actual current densities. Thus, the pit current decay after a maximum does not necessarily reflect the partial repassivation of the pit, as the enrichment of the electrolyte species near the pit mouth locally increases the electrolyte conductivity with time, resulting in underestimated current density if the global electrolyte conductivity is used for its calculation.

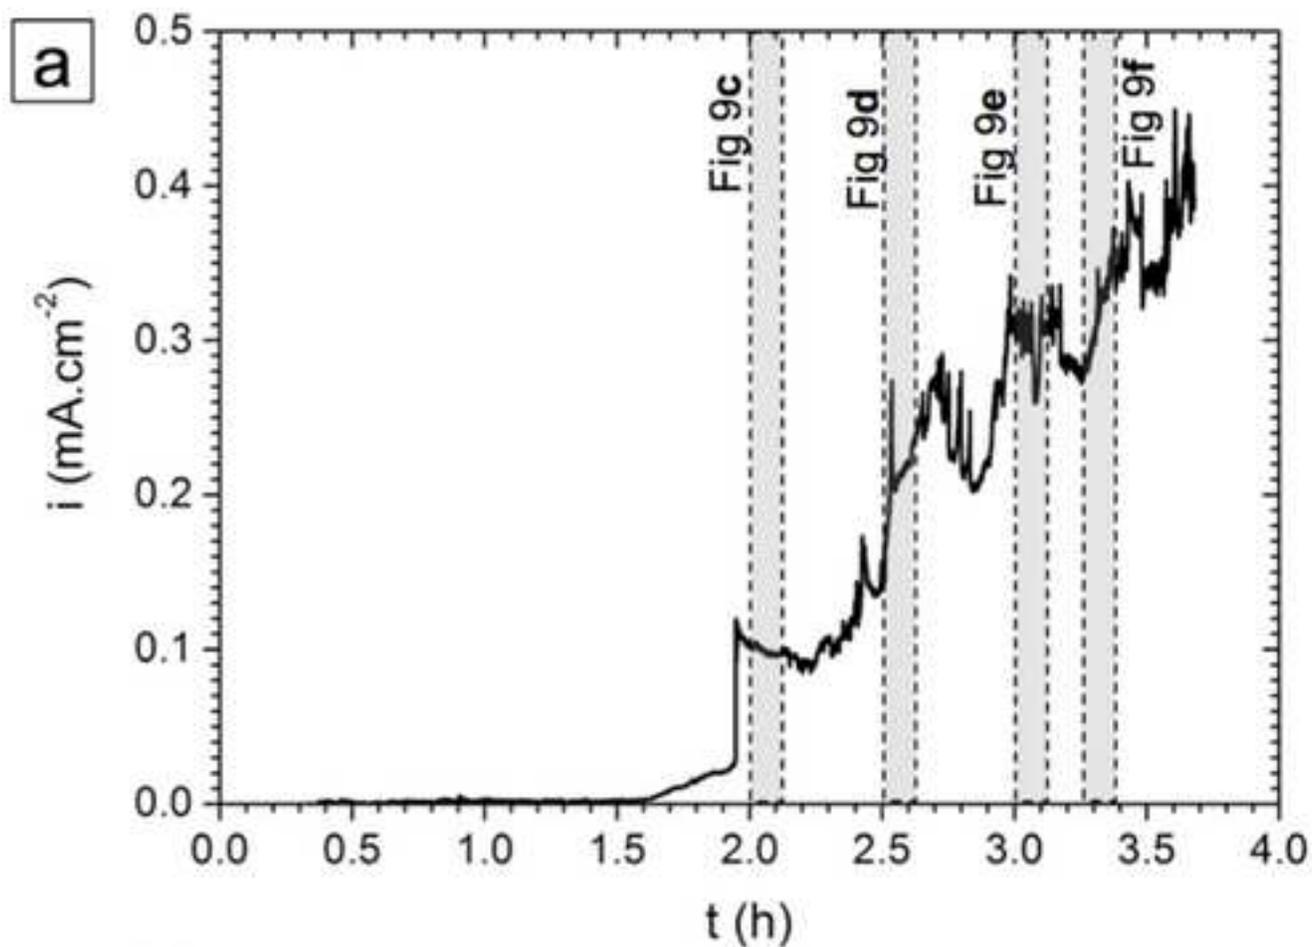
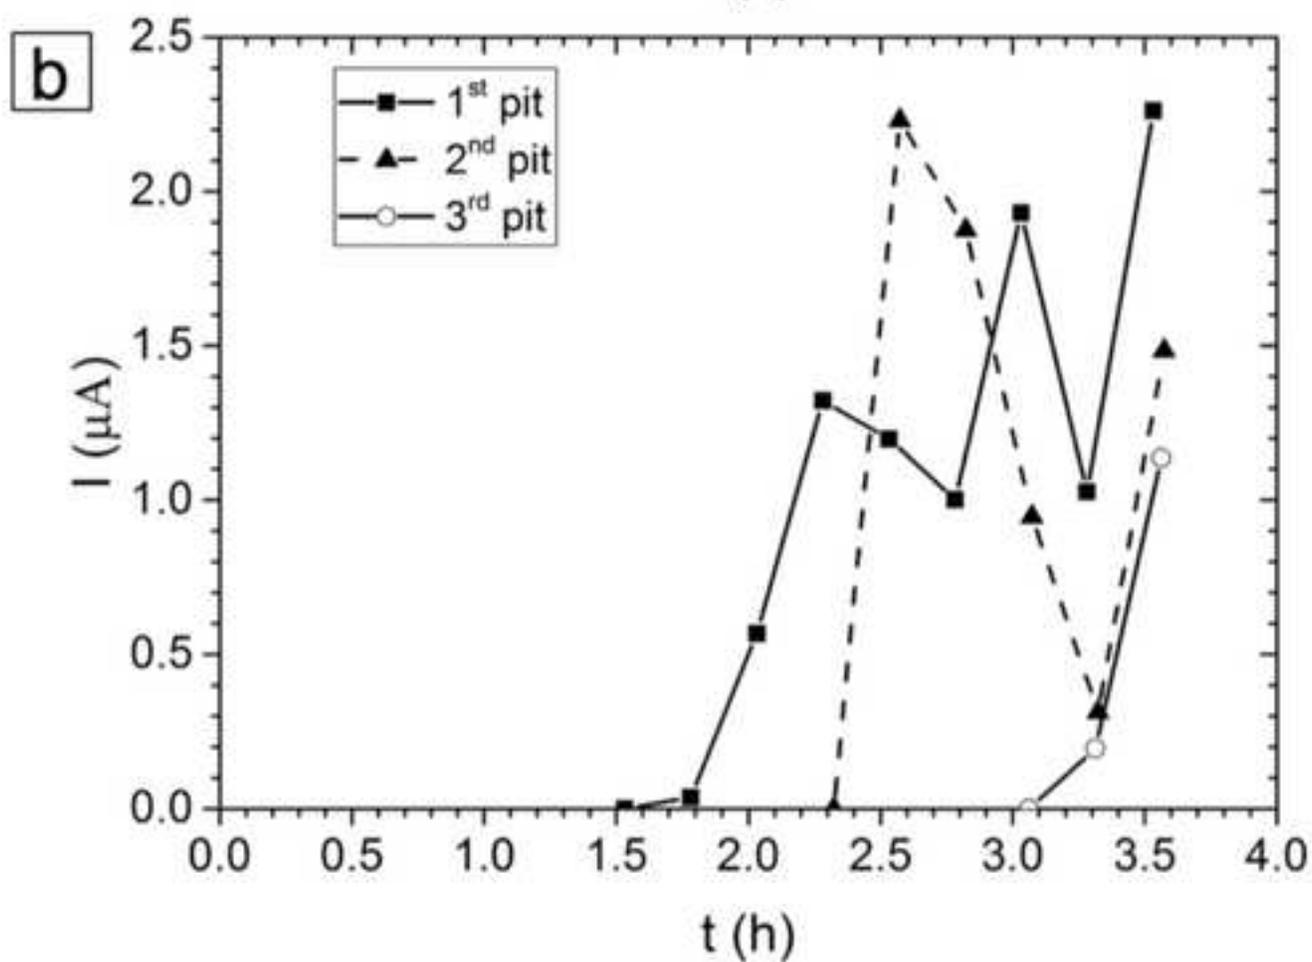
Fig. 10: a) Global current density transient of anodised friction stir welded AA7050 during SVET measurements, with anodic polarization of -390 mV/SHE, in 0.1M NaCl. b) Single pit current transients calculated from sequential SVET maps.

discussed (**Figs. 9c-f**). In addition, the total current was acquired by the potentiostat and a plot of global current density (considering the whole area exposed to the electrolyte) over time is shown in **Fig. 10a**. The comparison between global current density plots and SVET maps facilitates the interpretation of both results and provides information from corrosion events outside the area scanned by SVET.

The evolution of current density in time for single pits can be derived from the analysis of sequential SVET current density maps. The positive current densities were integrated over each pit shown in the SVET maps of **Fig. 9** and are presented on the same time scale in **Fig. 10b**. After nucleation, the indirectly calculated pit current grows approximately linearly with time, reaching a maximum value of slightly above $2 \mu\text{A}/\text{pit}$. Comparing **Fig. 10a** (global current density) with **Fig. 10b** (calculated individual pit currents), it is possible to see that pit current rises are in good agreement with global current density rises, but show individual values which are roughly two orders of magnitude lower than the values of the global current density related to the total sample area at the same time. If

the exposed area of $11.6 \cdot 10^{-2} \text{ cm}^2$ is considered, the global current still results in values $10 \mu\text{A} < I < 40 \mu\text{A}$) which are one order of magnitude higher than the integrated pit currents calculated from SVET maps.
