Failure analysis at deep drawing of low carbon steels

This paper presents a comparison in behaviour of two Zn coated, low carbon steels during deep drawing of bearing housing. The failures occurred during deep drawing process only for one steel. The experimental work consisted of a visual inspection, microscopic examination and chemical analysis of both materials. Metallurgical tests revealed the difference in microstructure and in carbon content. The anisotropy in behaviour was observed during deep drawing process. Metallography confirmed formation of longitudinal micro and macrocracks and elongated chains of cementite particles in matrix of ferrite. This study highlights the detrimental effect of the interface cementite particle/ferrite matrix as the main reason for the microcracks formation and reduction of steel capacity for deep drawing.

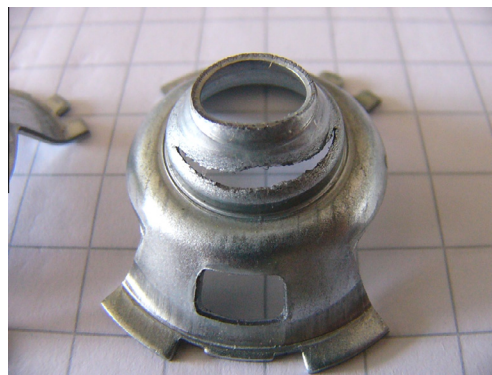
Fig. 3. Fracture of the wall. The fracture in direction of rolling of material shows worse workability of sheet in transversal direction, Steel 2: The grid is 1×1 cm.

In the presented study, the behaviour of two steels during deep drawn process are described. The cracks were observed during deep drawing process only at Steel 2. The cracks appeared in longitudinal direction of rolling of sheet. From the appearance of cracks is evident that fracture occurred because the material is anisotropic, had not enough workability and could not resist internal stresses during deep drawing process. Comparison of properties of Steel 1 and Steel 2 were performed.

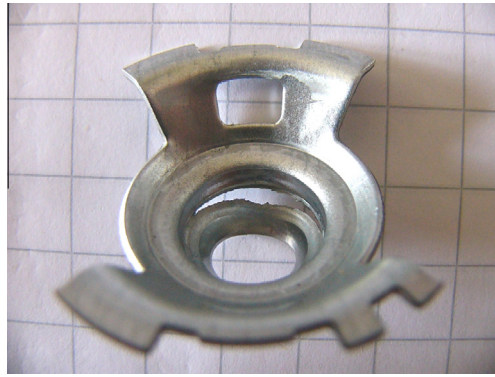
Fig. 4. Internal part of the housing with fracture, Steel 2: The grid is 1×1 cm.
