Microstructural Characterization of SCC Crack Tip and Oxide Film for SUS 316 Stainless Steel in Simulated PWR Primary Water at 320°C

Takumi TERACHI*, Katsuhiko FUJII and Koji ARIOKA

Institute of Nuclear Safety System, Inc., 64 Sata, Mihama-cho, Mikata-gun, Fukui 919-1205

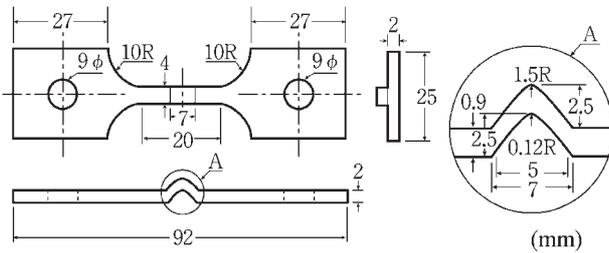
**Fig. 1** Specimen dimensions of the CERT test

The material used in this study was 316SS, which was solution-treated at 1,150°C for 10 min then water-quenched. The chemical composition is shown in **Table 1**. The crack tip and oxide film used for the analysis were prepared by the CERT test with a high-temperature water circulating system. **Figure 1** shows the morphology of the CERT test specimen. To accelerate the susceptibility to cracking, a

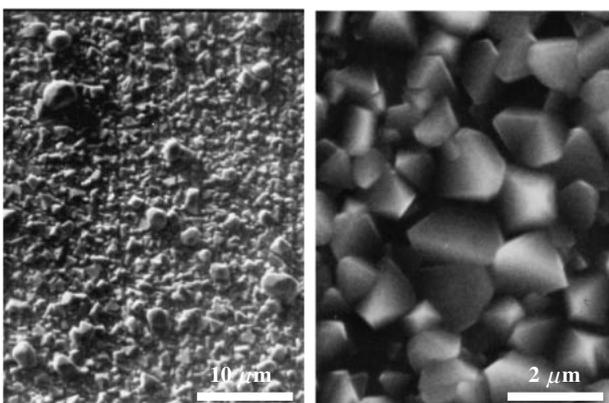
**Fig. 2** SEM image of the oxide film composed on the specimen surface after exposure to hydrogenated high temperature water

cold-worked hump was prepared in the gauge section of the specimen.³⁰ These tests were conducted in the typical chemical environment of simulated PWR primary water chemistries of the middle of the fuel cycle (B: 500 ppm, Li: 2 ppm, DH: 2.75 ppm, 320°C). The extension rate was kept constant throughout the experiment at 0.12 μm/min, and the experimental time was approximately 500 h. The crack morphology was mixed; it initiated in IGSCC then transited to transgranular stress corrosion cracking and finally to ductile. The result of the CERT test was reported previously;² in this paper we are not concerned about the SCC growth rate. The crack used for cross-sectional TEM observation is nucleated around the main crack and is approximately 20–100 nm long. Images of the oxide film formed on the specimen surface are shown in **Fig. 2**. The surface of the specimen was covered with octahedral particles that ranged from 0.2 to 3 μm in diameter.

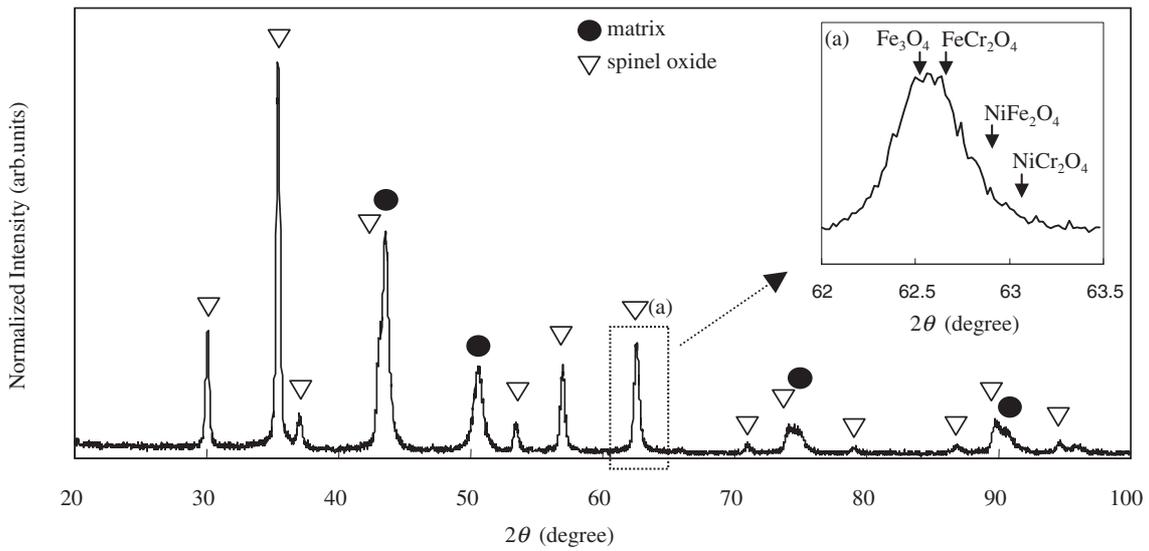
Fig. 3 X-ray diffraction profiles of the specimen using Cu-K α radiation at incidence angles of less than 1 $^\circ$: (a) Enlargement of the area surrounding the spinel oxide (440) peak

Figure 3 shows a typical XRD profile from the gauge section of the tested specimen. All measurement peaks agree with that from the spinel oxide, with the exception of the matrix, and neither a hydroxide peak nor a corundum (Cr₂O₃) peak is observed. **Figure 3(a)**, an inset within **Fig. 3**, shows the spinel oxide (440) peak in detail. It indicates that the spinel oxide is dominated by Fe₃O₄ and FeCr₂O₄.

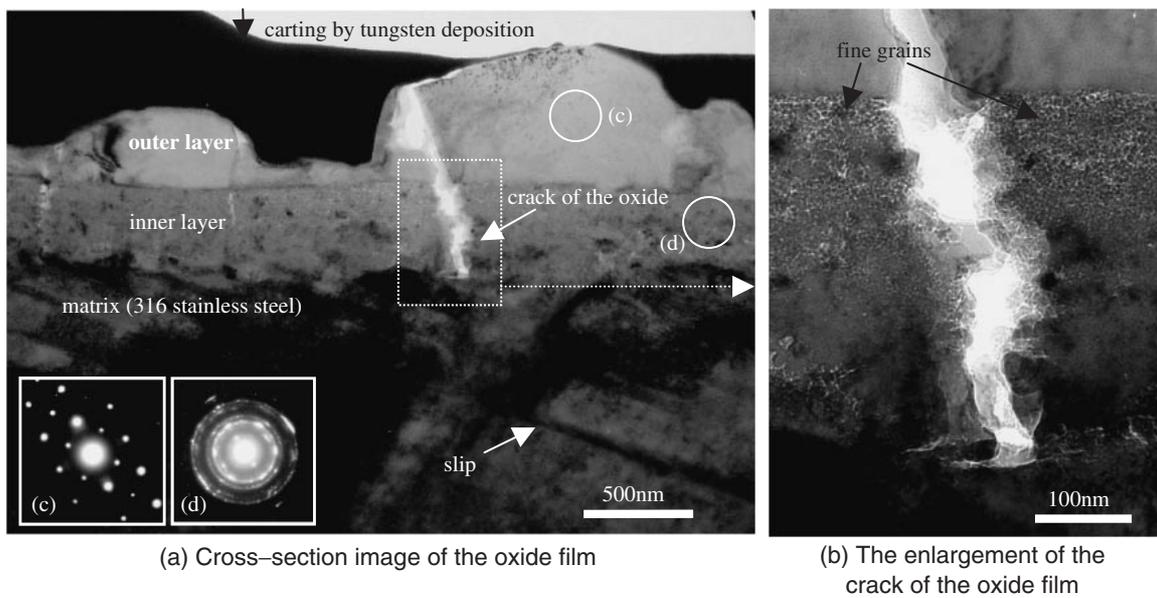
Fig. 4 Cross-sectional TEM image of the oxide film composed on the specimen surface formed under hydrogenated high-temperature water: (c) Outer layer diffraction pattern with spot from spinel oxide, (d) Diffraction pattern with rings from fine grained spinel oxide

Figure 4 shows a cross-sectional TEM image of the oxide film, which has a double-layer structure. The outer layer consists of single crystal particles, 1–2 μm in diameter. On the other hand, the inner layer, approximately 500 nm in depth, consists of fine grains of polycrystal. Several cracks observed in the oxide film were not located on the grain boundaries of the base material in this observation.

Examples of the electron diffraction patterns from the oxide film are shown also in **Figs. 4(c), (d)**. The patterns from both the inner and outer layers were in agreement with the spinel structure. Since the diffraction pattern shows a spot image, the outer layer is considered to be a single crystal and not a polycrystal. In contrast, the structure of the inner layer is identified as having a ring diffraction pattern, confirming that the inner layer consists of fine grains of spinel oxides.

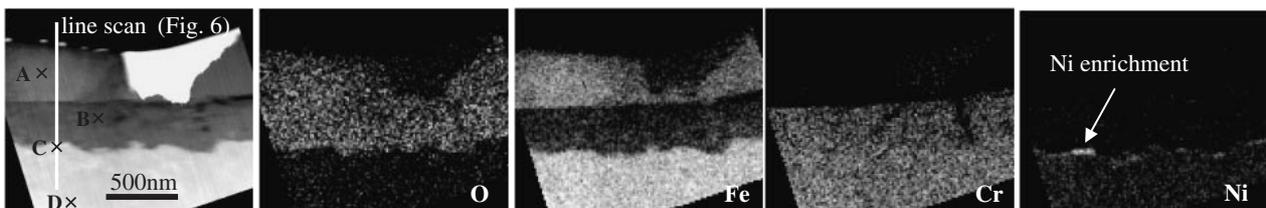
Fig. 5 Elemental maps of the oxide film obtained by EDS. Marked areas refer to: outer layer (A), inner layer (B), outer layer/inner layer interface (C), matrix (D), as shown in Fig. 7

The elemental maps for oxygen, iron, chromium and nickel in a cross-sectional area of the oxide film are shown in **Fig. 5**. The line scan analysis results are shown in **Fig. 6**. The outer layer was composed mainly of iron oxide. Relatively chromium-rich oxide was recognized in the inner layer. These compositional details agree with the results published for oxide films formed in high-temperature pure water.¹⁴⁾ In addition, nickel enrichment was observed at the oxide/metal interface, at up to 70 nm in depth. The quantitative element analysis (point analysis) by EDS, shown in **Fig. 7**, indicates that nickel is enriched in a matrix by more than twice its bulk concentration. Furthermore, we attempted to examine the effect of molybdenum on additional corrosion resistance in simulated PWR primary water. However, as shown in **Figs. 6 and 7**, molybdenum enrichment was not observed in the oxide film.

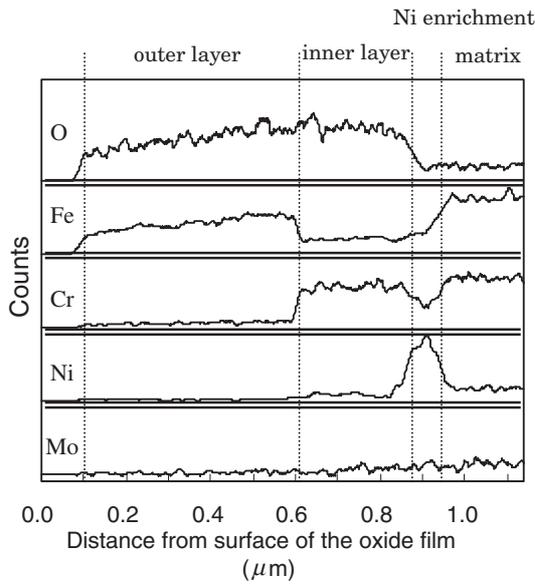
Fig. 6 EDS line scan profiles across the oxide film
The analysis area is shown in Fig. 5.

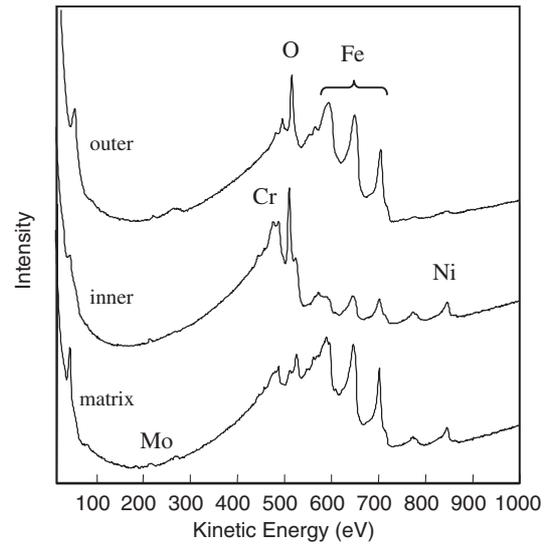
Fig. 8 AES analysis of the cross-sectional oxide film

Figure 8 shows AES spectra from the outer and inner oxide films and the matrix of the cross-sectional sample. At approximately 178 eV, peaks of boron, whose detection limit is approximately 0.1 at.%, were not observed in either the outer or inner layer of the oxide.

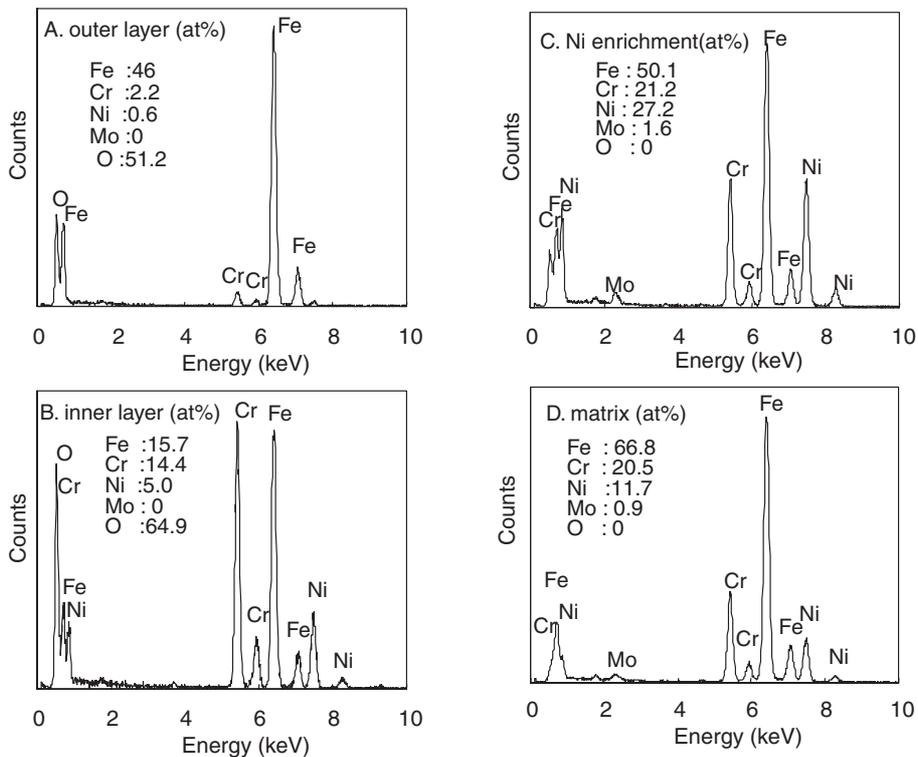
Fig. 7 Chemical compositions of the oxide film with matrix obtained by EDS. The analysis area is marked on Fig. 5

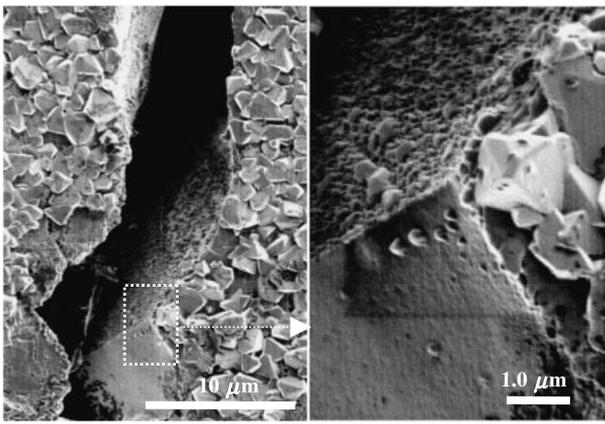
Fig. 9 SEM image of the initiation stage of the crack

An SEM image of the initiation area of intergranular

cracking is shown in **Fig. 9**. Although grown octahedral particles occupied the surface of the specimen, only smaller particles were observed on the fracture facet. The quantity of corrosion products formed on each granular facet was inconsistent with that formed on the same crack.

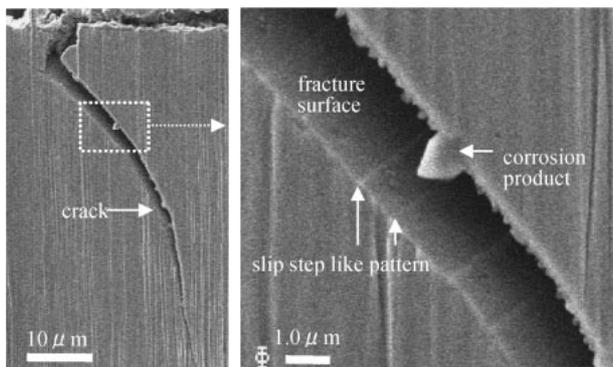
Fig. 10 SEM cross-sectional image of the crack

Figure 10 shows a cross-sectional SEM image of a crack. The grained corrosion products are formed on only one side of the crack surface. Additionally, slip step-like patterns were observed on the fracture surface.

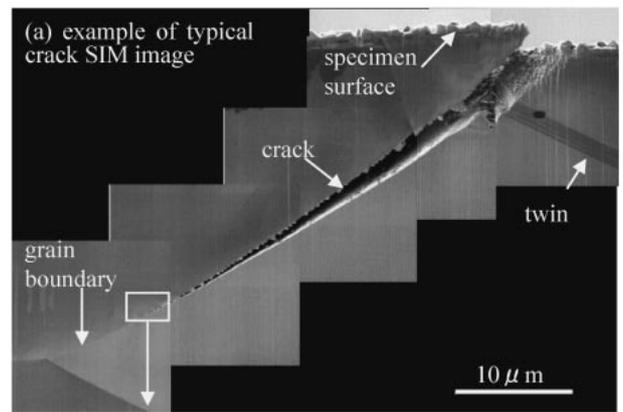
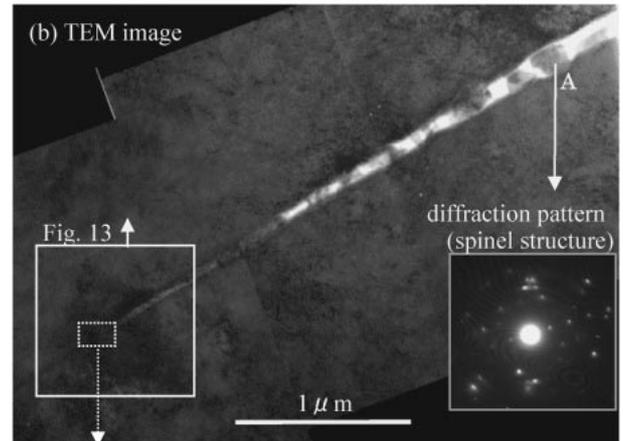
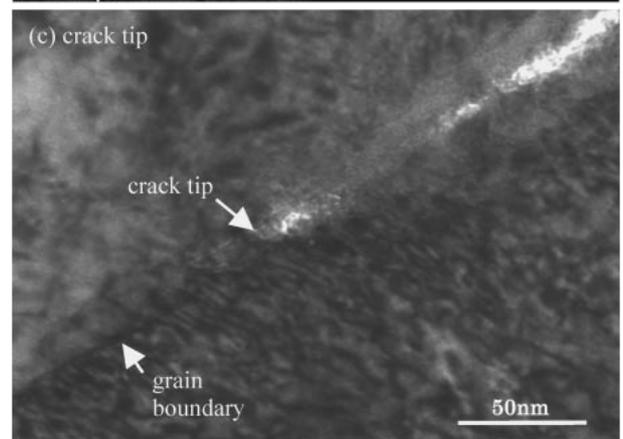
Fig. 12 Cross-section crack morphology: (a) SEM image of a typical crack, (b) low-magnification TEM image, (c) TEM image of the crack tip region

Figure 12 shows a cross section of the LPSCC crack formed under simulated PWR primary water conditions. The whole crack image shown in Fig. 12(a) indicates differences in the levels formed on the surface of the specimen. This finding suggests that grain boundary sliding has affected the cracking process, especially during the initiation stage. A low-magnification TEM image of the crack tip is shown in Fig. 12(b). Corrosion products are observed in the crack, which consists of a spinel structure, as determined by electron diffraction (as shown in Fig. 12(b)). Furthermore, the EDS spectrum shows the following composition (at.%): Fe, 39.1%; Cr, 2.3%; Ni, 2.6%; Mo, not detected;

and O, 56.1% (at.%). Thus, the main corrosion products are assumed to be Fe_3O_4 , which grows by the deposition of iron.

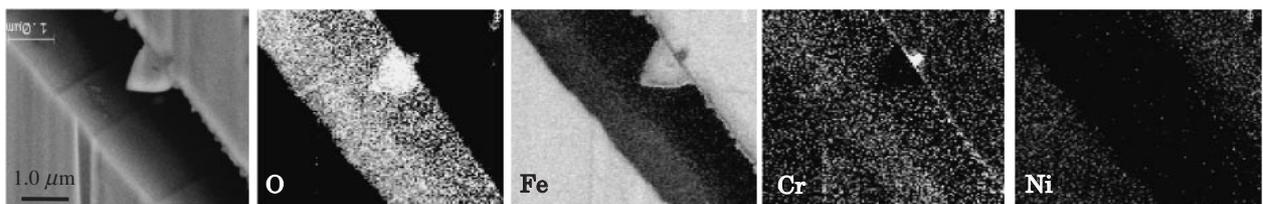
Fig. 11 Elemental maps of the cross-section of the crack obtained by AES

Figure 11 provides AES elemental maps for oxygen, iron,

chromium and nickel in the cross-sectional area of the crack. They show that the oxide film on the upper facet consists of an iron-rich outer layer and a chromium-rich inner layer of oxide, in agreement with the characteristics of the oxide film formed on the specimen surface.

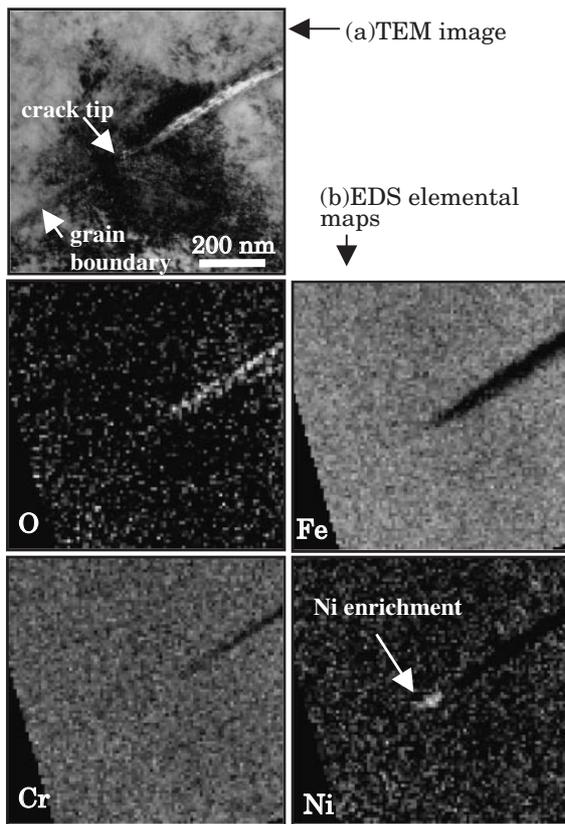
Fig. 13 TEM image of the crack tip region (a: enlarged region within Fig. 12), and EDS elemental maps from part of the sample shown in (a)

Figure 13 shows a TEM image and EDS elemental maps of the crack tip. The crack is filled with corrosion products. Additionally, metallic nickel enrichment at the crack tip is confirmed, as shown in Fig. 13(b). The chemical composition of the nickel enrichment area was measured by EDS as Fe, 56.7%; Cr, 21.9%; Ni, 15.1%; Mo, 6.4%; and O, not detected (at.%).

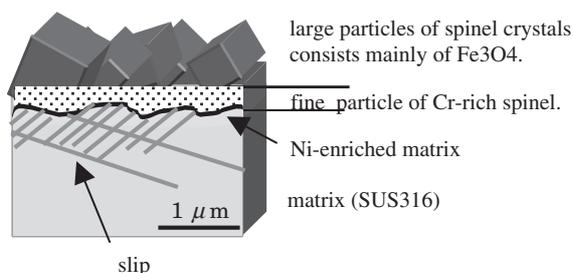
Fig. 14 Schematic representation of the oxide film formed on the surface of the CERT specimen exposed to simulated PWR primary water

The results of the oxide film characterization, formed in hydrogenated high-temperature water, are illustrated in Fig. 14.

The results by electron diffraction and EDS indicate that the outer oxide is composed of an iron-rich oxide with a spinel structure, which was supported by XRD analysis. Therefore, it is concluded that the outer layer is composed mainly of Fe_3O_4 due to the redeposition of iron. On the other hand, the inner oxide layer is composed of chromium-rich oxide with a spinel structure. The results of electron diffraction and TEM observation suggest that the inner layer is composed of fine grains.

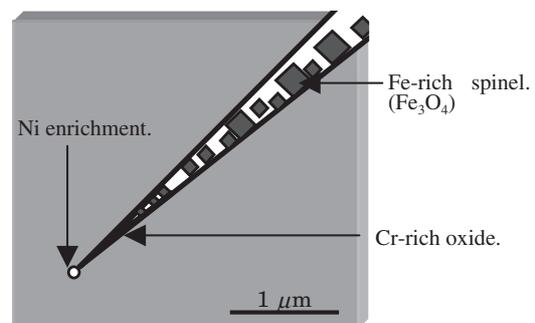
Fig. 15 Schematic representation of the crack tip formed in the CERT specimen under simulated PWR primary water

A cross-sectional view of the LPSCC crack is schematically shown in Fig. 15. From the microstructural analysis, it can be deduced that Fe_3O_4 precipitated at the crack wall and that the crack tip filled with corrosion products consisting mainly of chromium-rich oxide. Thus, the oxide film on the crack wall has the same structure as that formed on the specimen surface except for film thickness. This suggests that there is no large potential gradient between the surface of the specimen and the inside of the crack, in such a hydrogenated PWR primary environment. This result is inconsistent with that in an oxygenated condition such as that of boiling water reactors (BWR). The potential gradient in BWR environments is confirmed by the analytic result that the surface oxide consists mainly of $\alpha\text{-Fe}_2\text{O}_3$, even though Fe_3O_4
